MOHAWK RIVER BASIN  
TOWN OF GERMAN FLATTS  
HERKIMER COUNTY, NEW YORK

**ILION RESERVOIR  
NO. 2 DAM  
NY 00185**

PHASE I INSPECTION REPORT  
NATIONAL DAM INSPECTION PROGRAM

JULY 1981

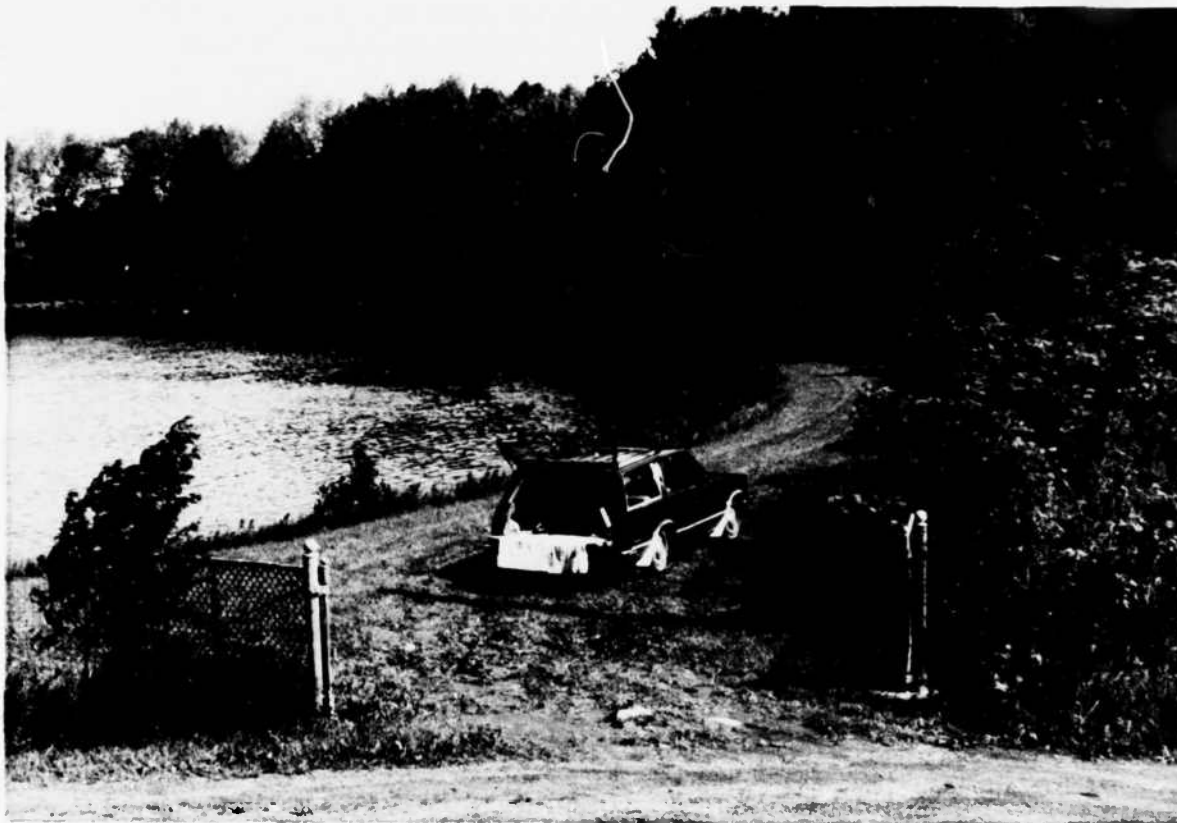
Overview Photo - Ilion Reservoir No. 2 Dam from road near right abutment - 6/4/81

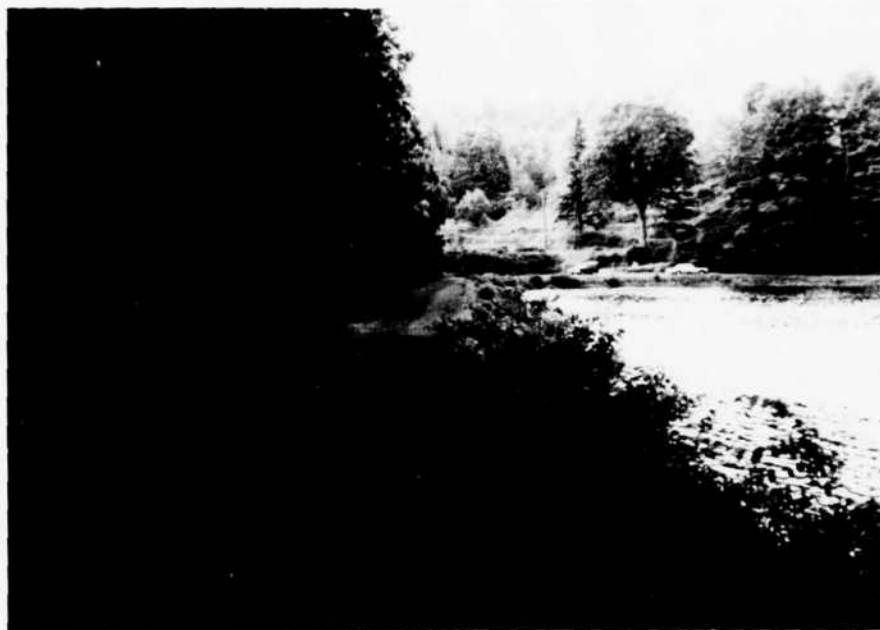
A-2A Top of dam viewed from about Sta 2+00 looking toward  
right abutment - 6/4/81

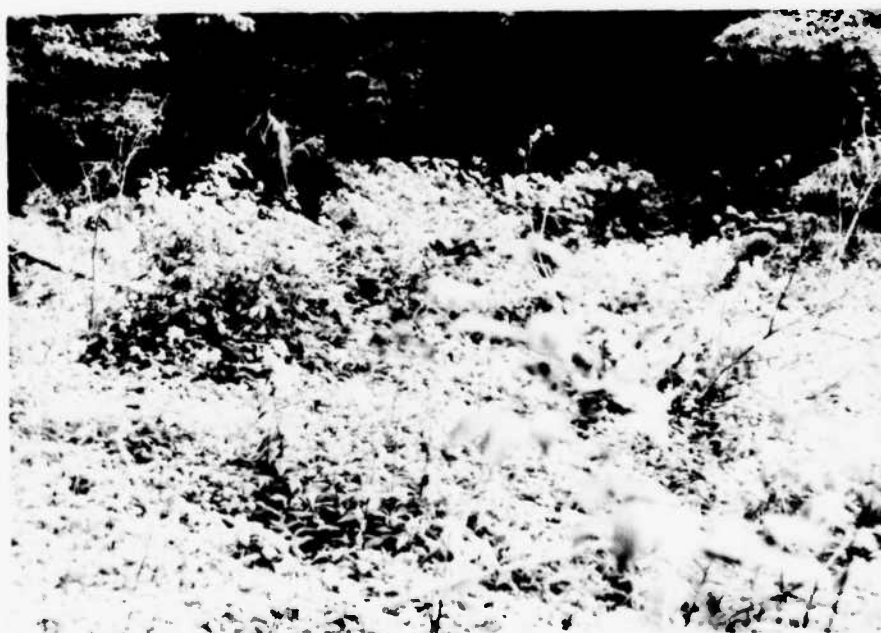
A-2B Cleared area to left of gate house at downstream toe of dam  
6/4/81

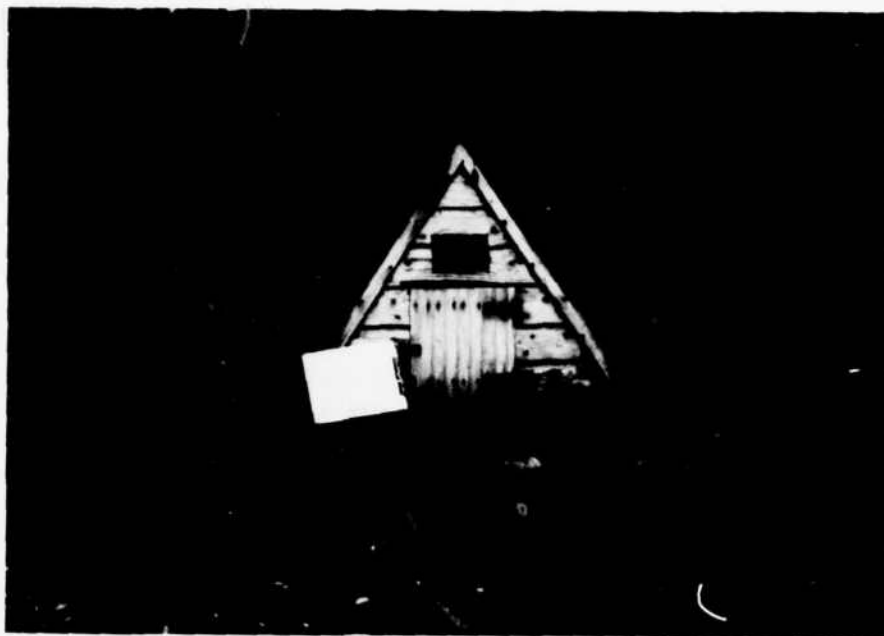
A spring house on natural ground about 40 feet downstream from the toe of the dam might become a focus for piping through the foundation of the dam, depending on the details of its construction and the character of the natural ground in which the spring is dug.

A-3A Spring house on natural ground about 40 feet from downstream toe and 22 feet lower than elevation of crest at about Sta 3+00  
6/4/81

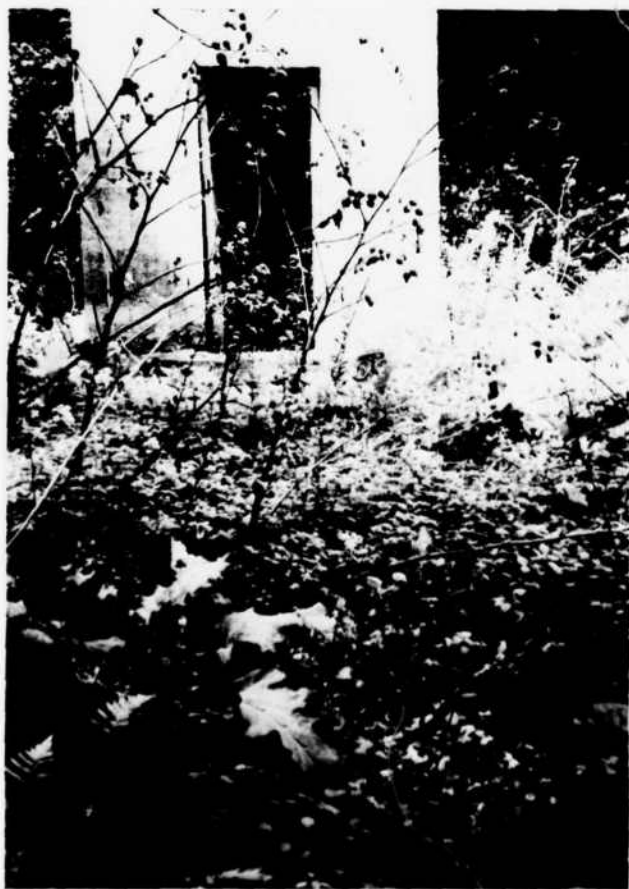
The gate house (see Photo A-3B) is a concrete structure with a wood-framed, slate-shingled roof. There is minor spalling and cracking of its surface concrete and the door and lock were broken.

A-3B Gate house at downstream toe.  
Note valve box for valve on outlet pipe downstream of gate house  
6/4/81

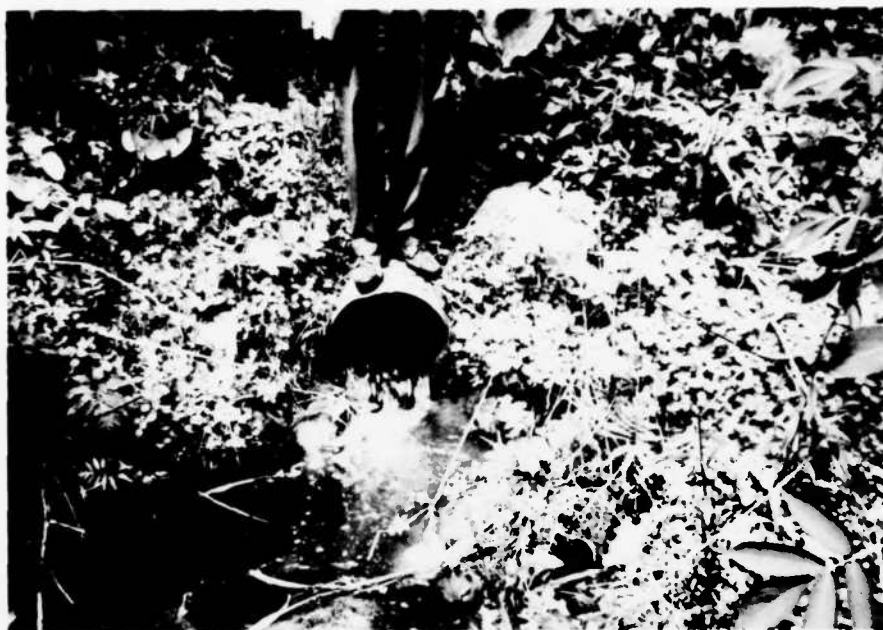
A-5A Culvert at downstream end of blowoff - 6/4/81

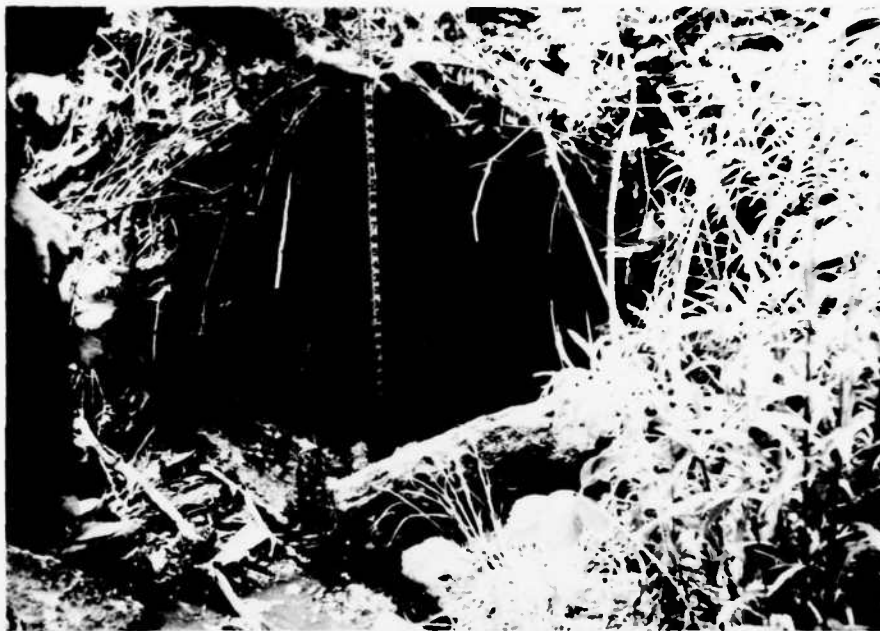
A-6A Downstream end of pipe from service spillway at ditch near Elizabethtown Road - 6/4/81

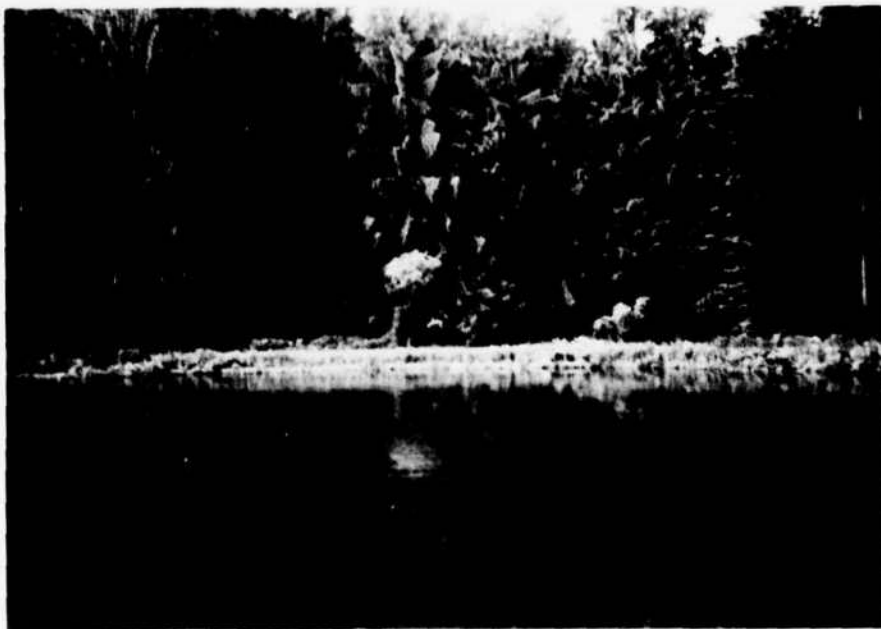
The auxiliary spillway consists of a concrete structure with a 4.5-foot-long ogee weir crest that discharges into a 15-foot-long section of 18-inch-diameter corrugated metal pipe (see Photos A-6B and A-7A). The weir structure concrete is weathered and stained. The 18-inch pipe from it is laid level and in good condition.

A-6B End of reservoir opposite dam. Note auxiliary spillway structure at center - 6/4/81

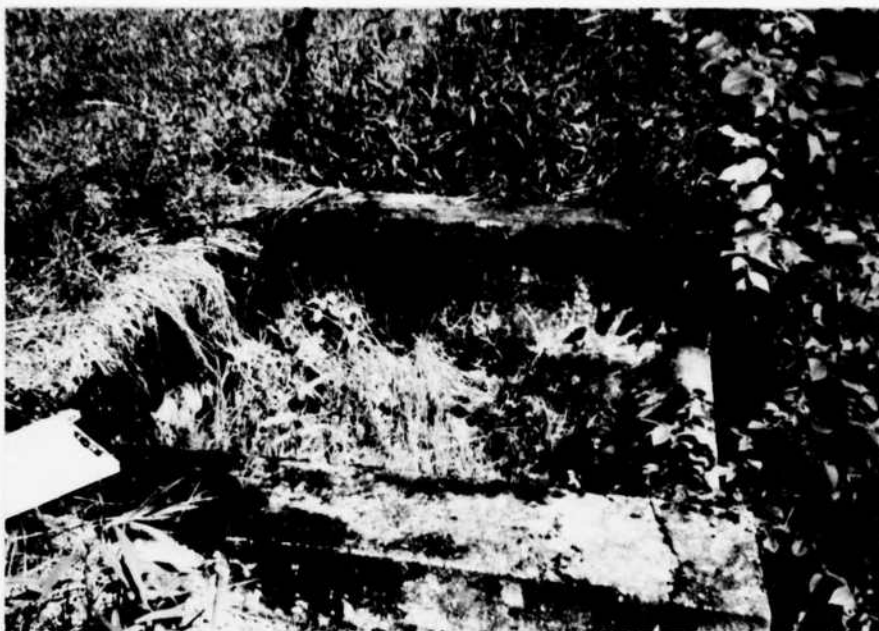
A-7A Overflow weir, right side of photo, and outlet culvert, left side of photo, of auxiliary spillway - 6/4/81

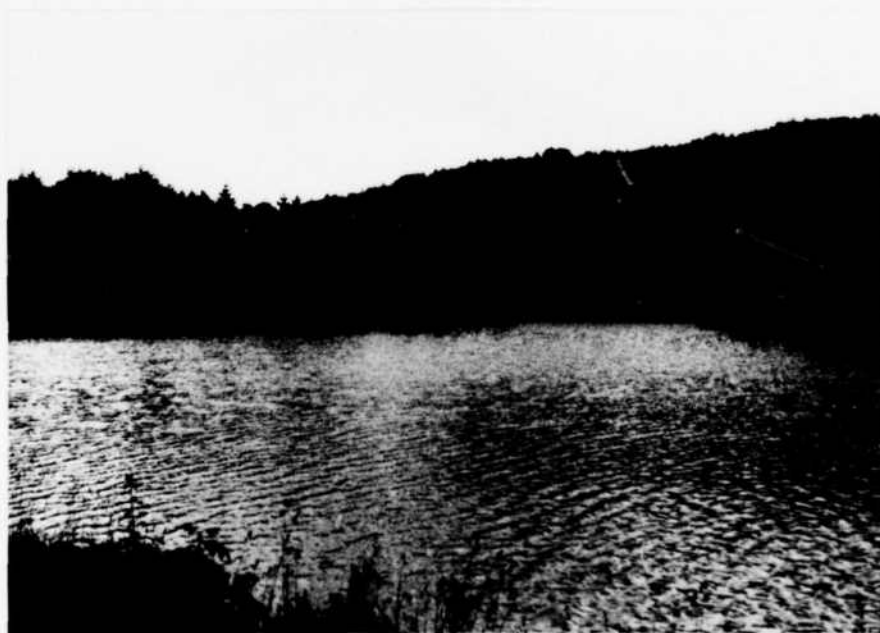
No evidence was observed to indicate problems of slope stability on the perimeter of the reservoir or of significant sedimentation in the reservoir (see Photo A-9B).

A-9B Reservoir and dam viewed from area upstream of left abutment  
6/4/81
